To: August Preschle, Manager, World Trade Center Operations
From: Harry R. Pool, Jr.
Date: March 24, 1988
Subject: THE WORLD TRADE CENTER - ASBESTOS INVESTIGATION AND ANALYSIS REPORT
Copy to: F. Boyce, N. Budeiri, D. Darcy, J. Davison, D. Hahn, P. LaRocco, D. Leahy, R. Linn, P. Maurer, D. Moncalbano, J. Pearse, S. Samperi, V. Strom

ASBESTOS INVESTIGATION AND ANALYSIS REPORT
WORLD TRADE CENTER
VOLUME I OF II

ENVIRONMENTAL MANAGEMENT DIVISION
MARCH 21, 1988

THE WORLD TRADE CENTER

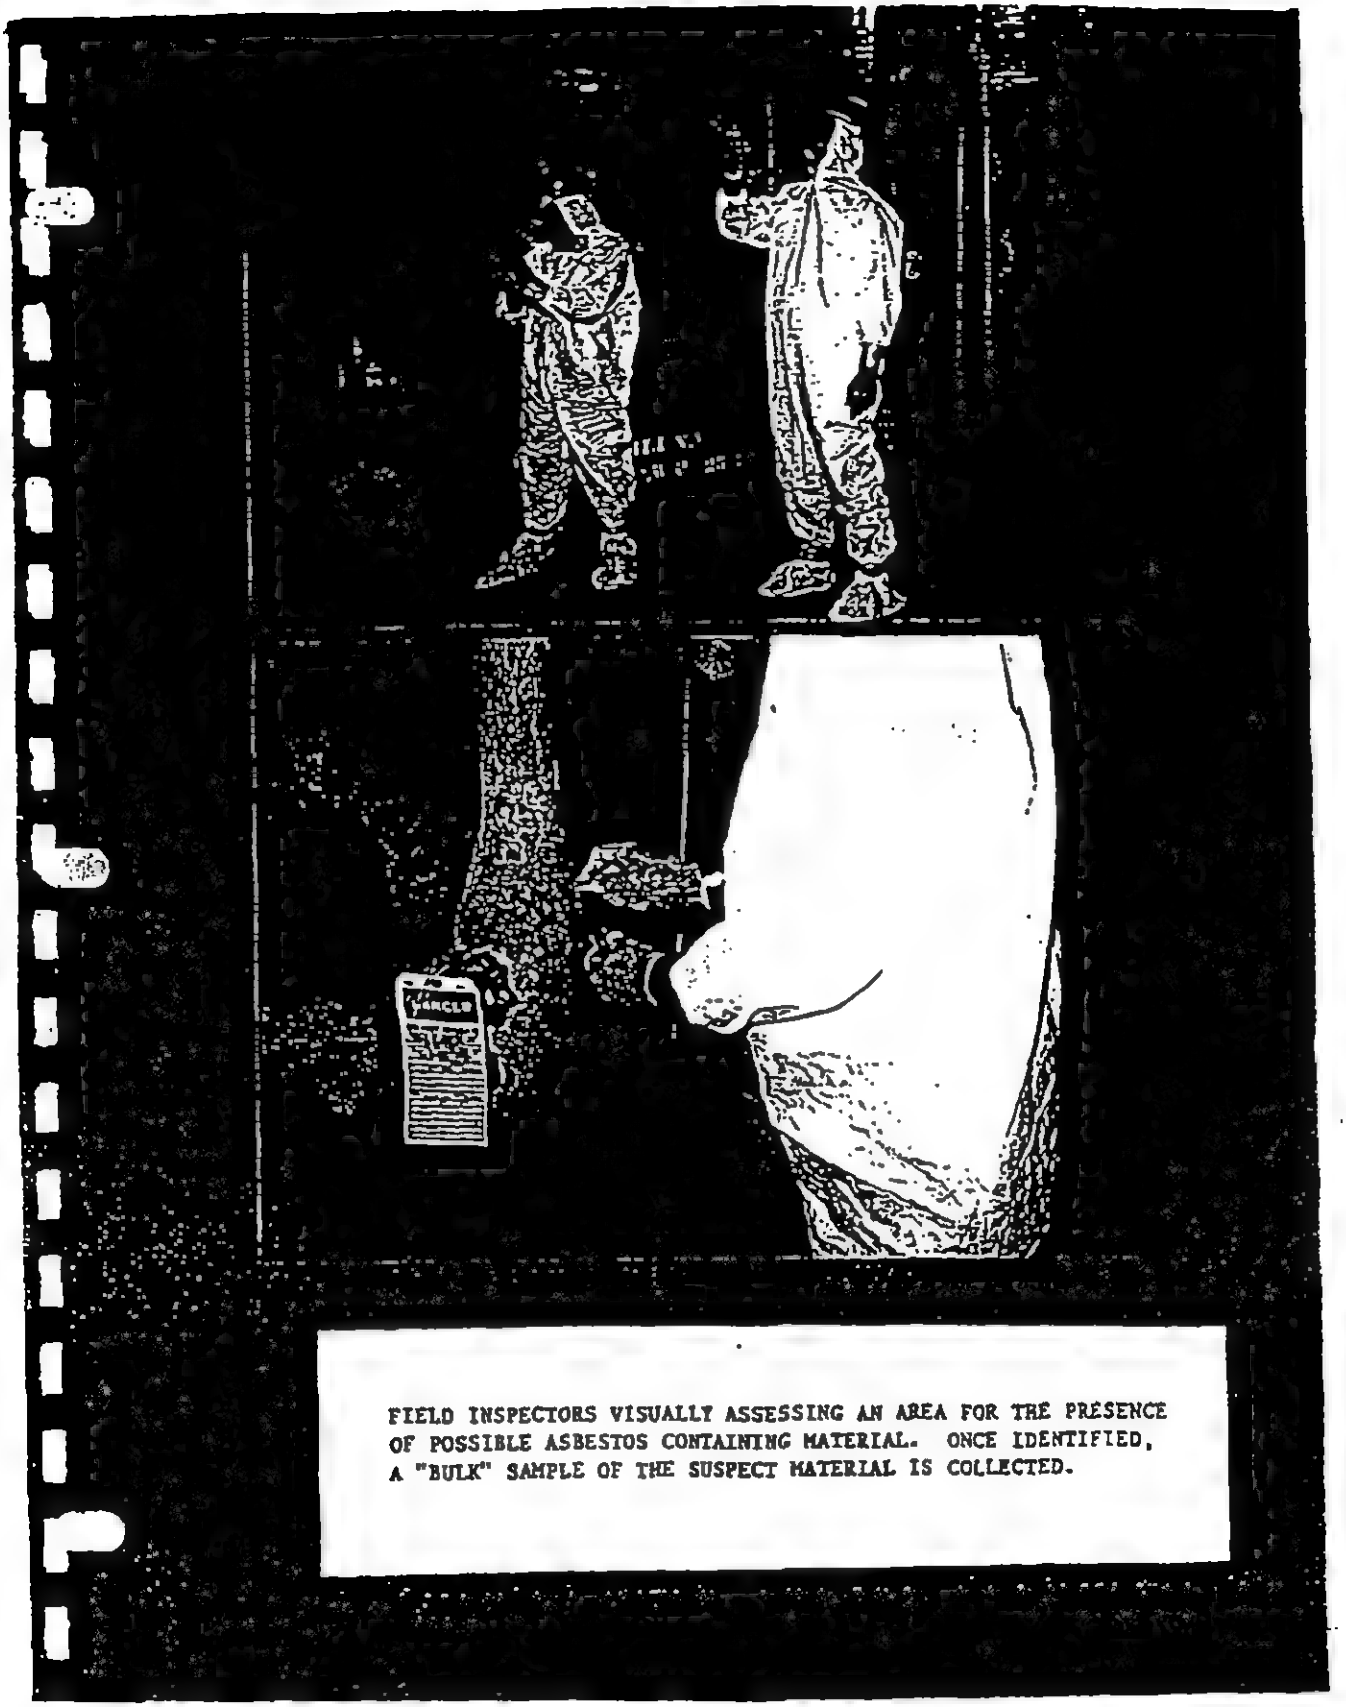
FIELD INSPECTORS VISUALLY ASSESSING AN AREA FOR THE PRESENCE OF POSSIBLE ASBESTOS CONTAINING MATERIAL. ONCE IDENTIFIED, A "BULK" SAMPLE OF THE SUSPECT MATERIAL IS COLLECTED.

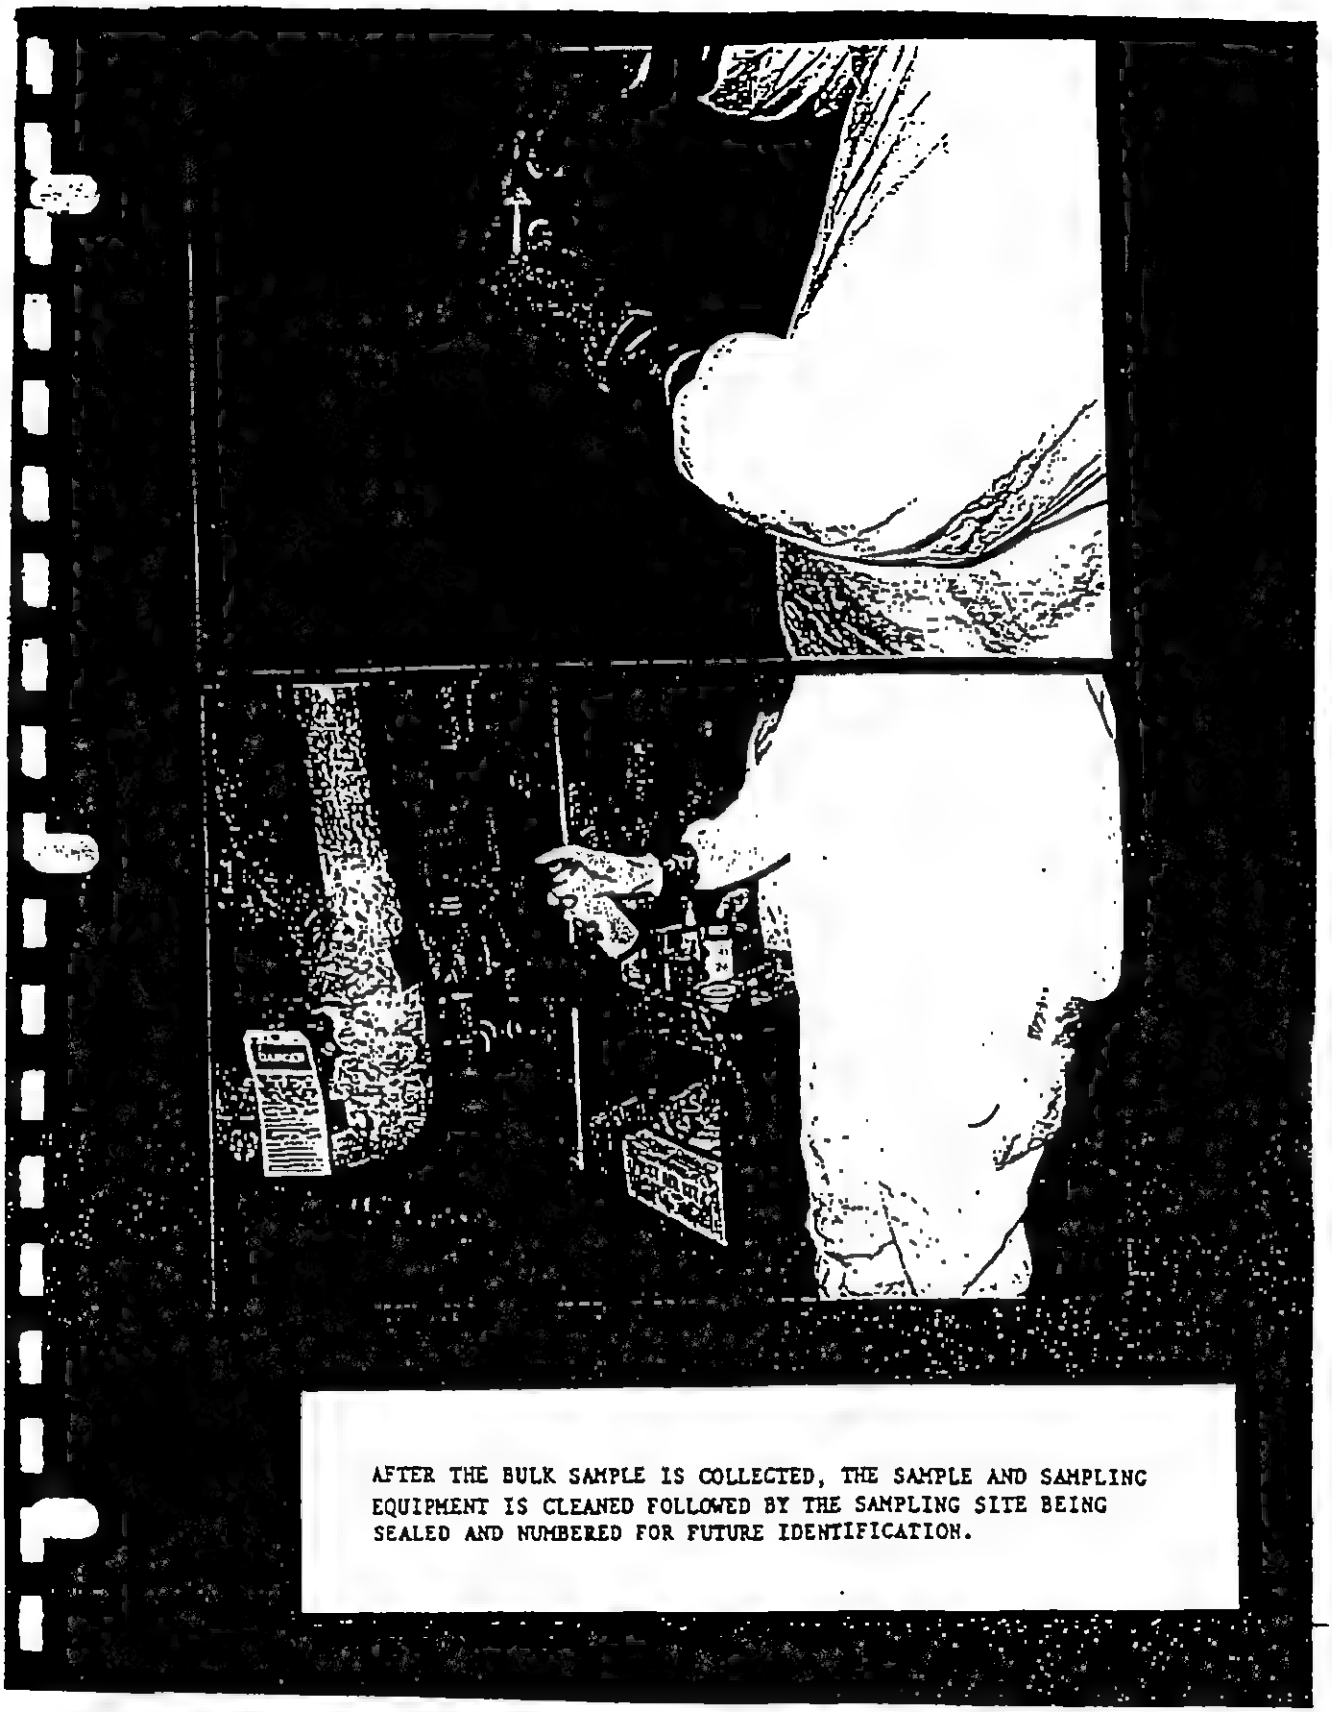
AFTER THE BULK SAMPLE IS COLLECTED, THE SAMPLE AND SAMPLING EQUIPMENT IS CLEANED FOLLOWED BY THE SAMPLING SITE BEING SEALED AND NUMBERED FOR FUTURE IDENTIFICATION.

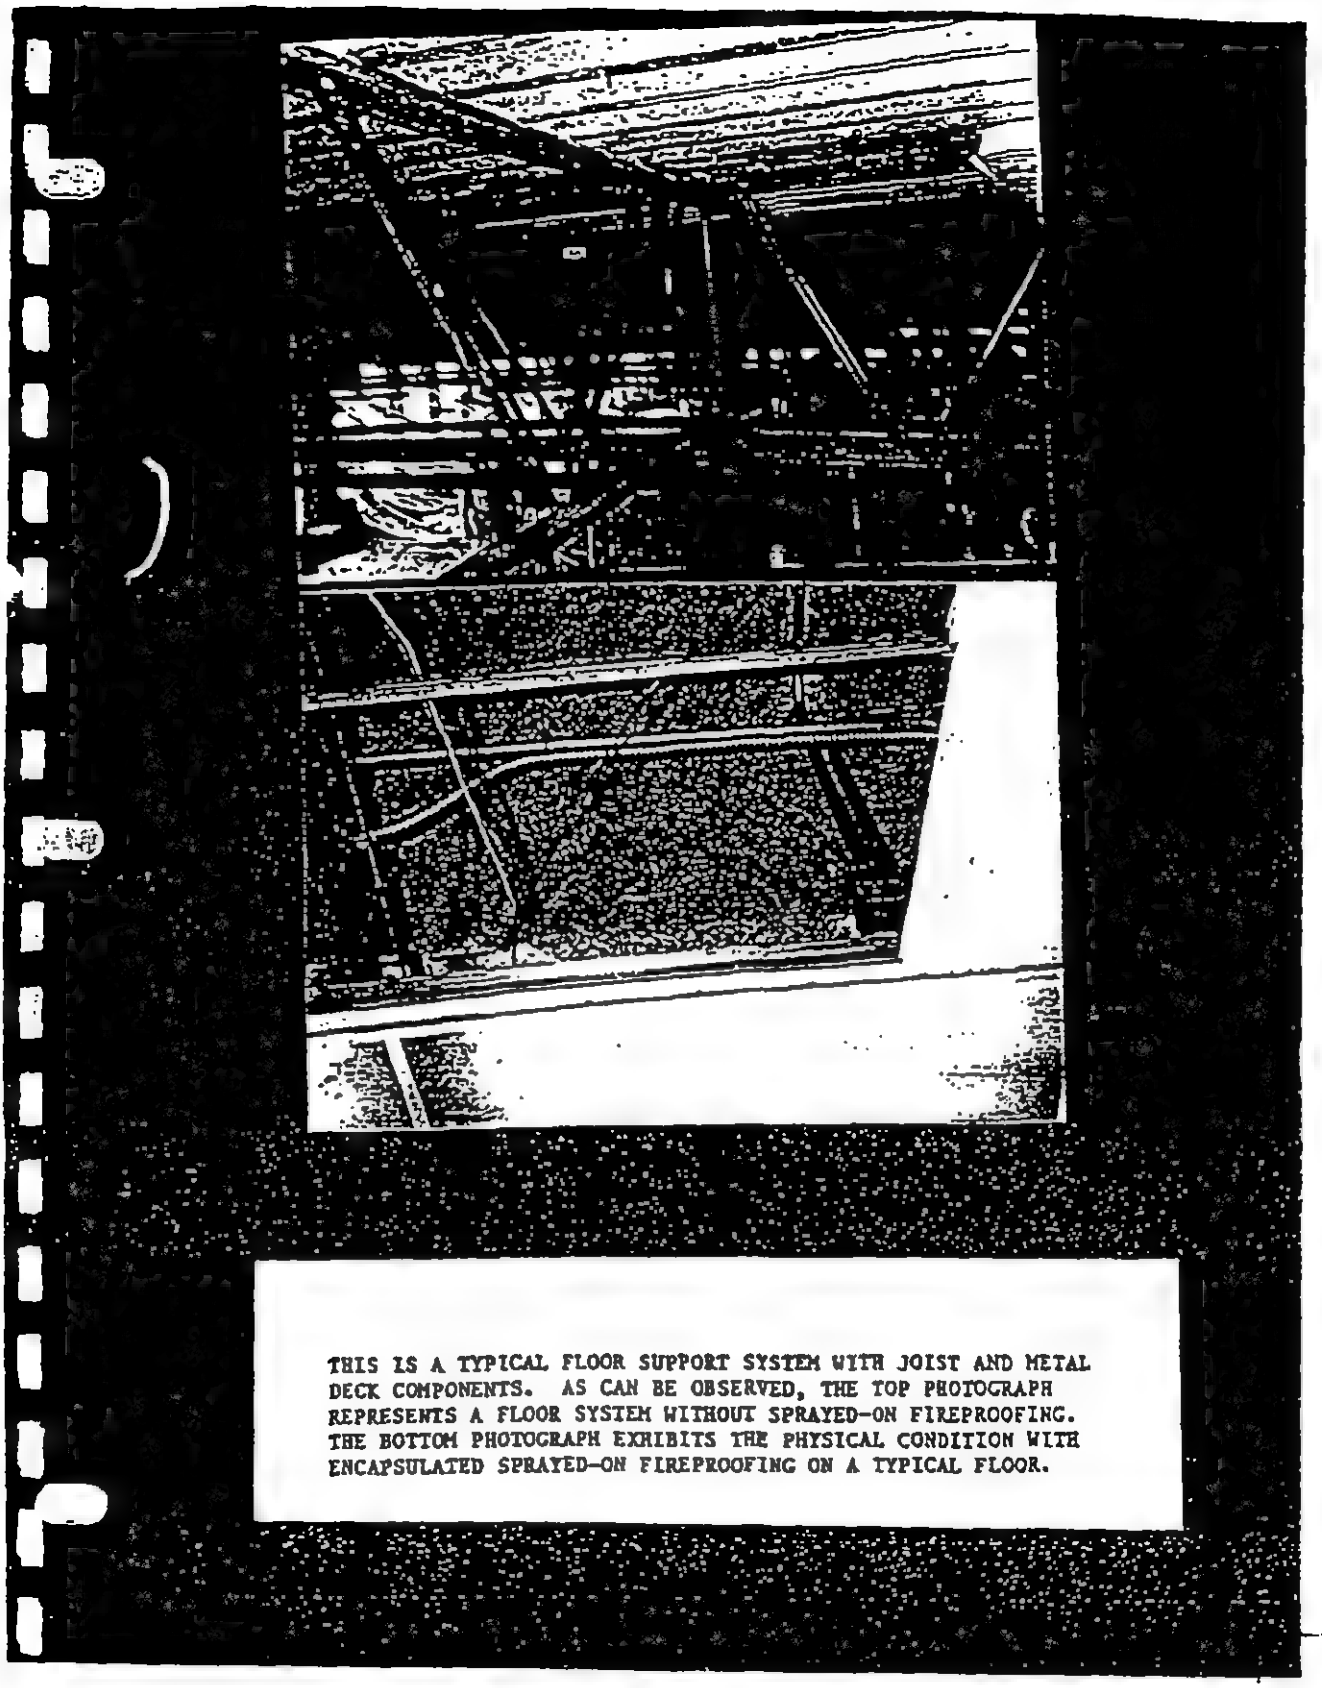
THIS IS A TYPICAL FLOOR SUPPORT SYSTEM WITH JOIST AND METAL DECK COMPONENTS. AS CAN BE OBSERVED, THE TOP PHOTOGRAPH REPRESENTS A FLOOR SYSTEM WITHOUT SPRAYED-ON FIREPROOFING. THE BOTTOM PHOTOGRAPH EXHIBITS THE PHYSICAL CONDITION WITH ENCAPSULATED SPRAYED-ON FIREPROOFING ON A TYPICAL FLOOR.

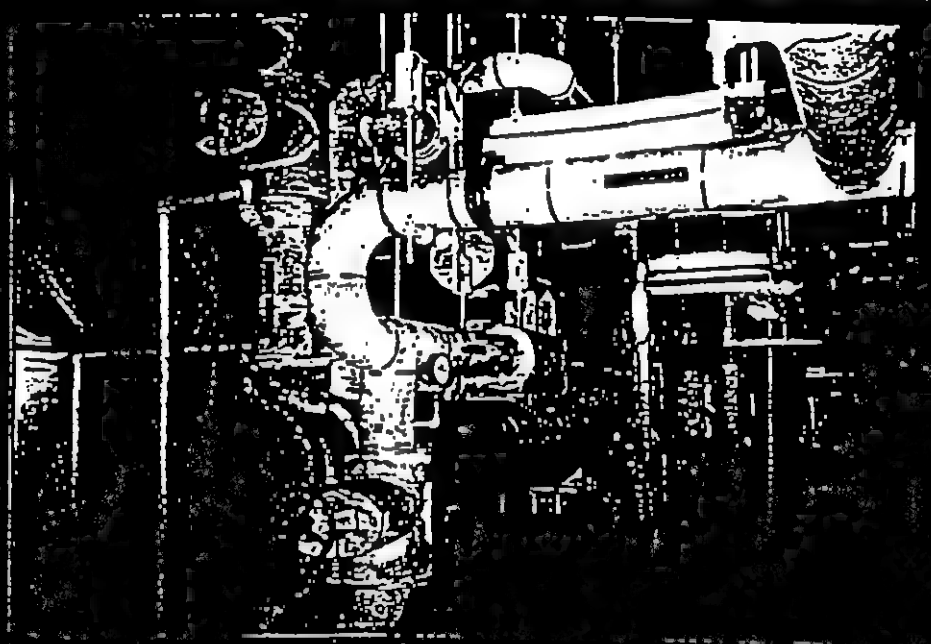
THE FOLLOWING PHOTOGRAPHS REPRESENT VARIOUS MECHANICAL SYSTEMS IN THE EQUIPMENT ROOMS.

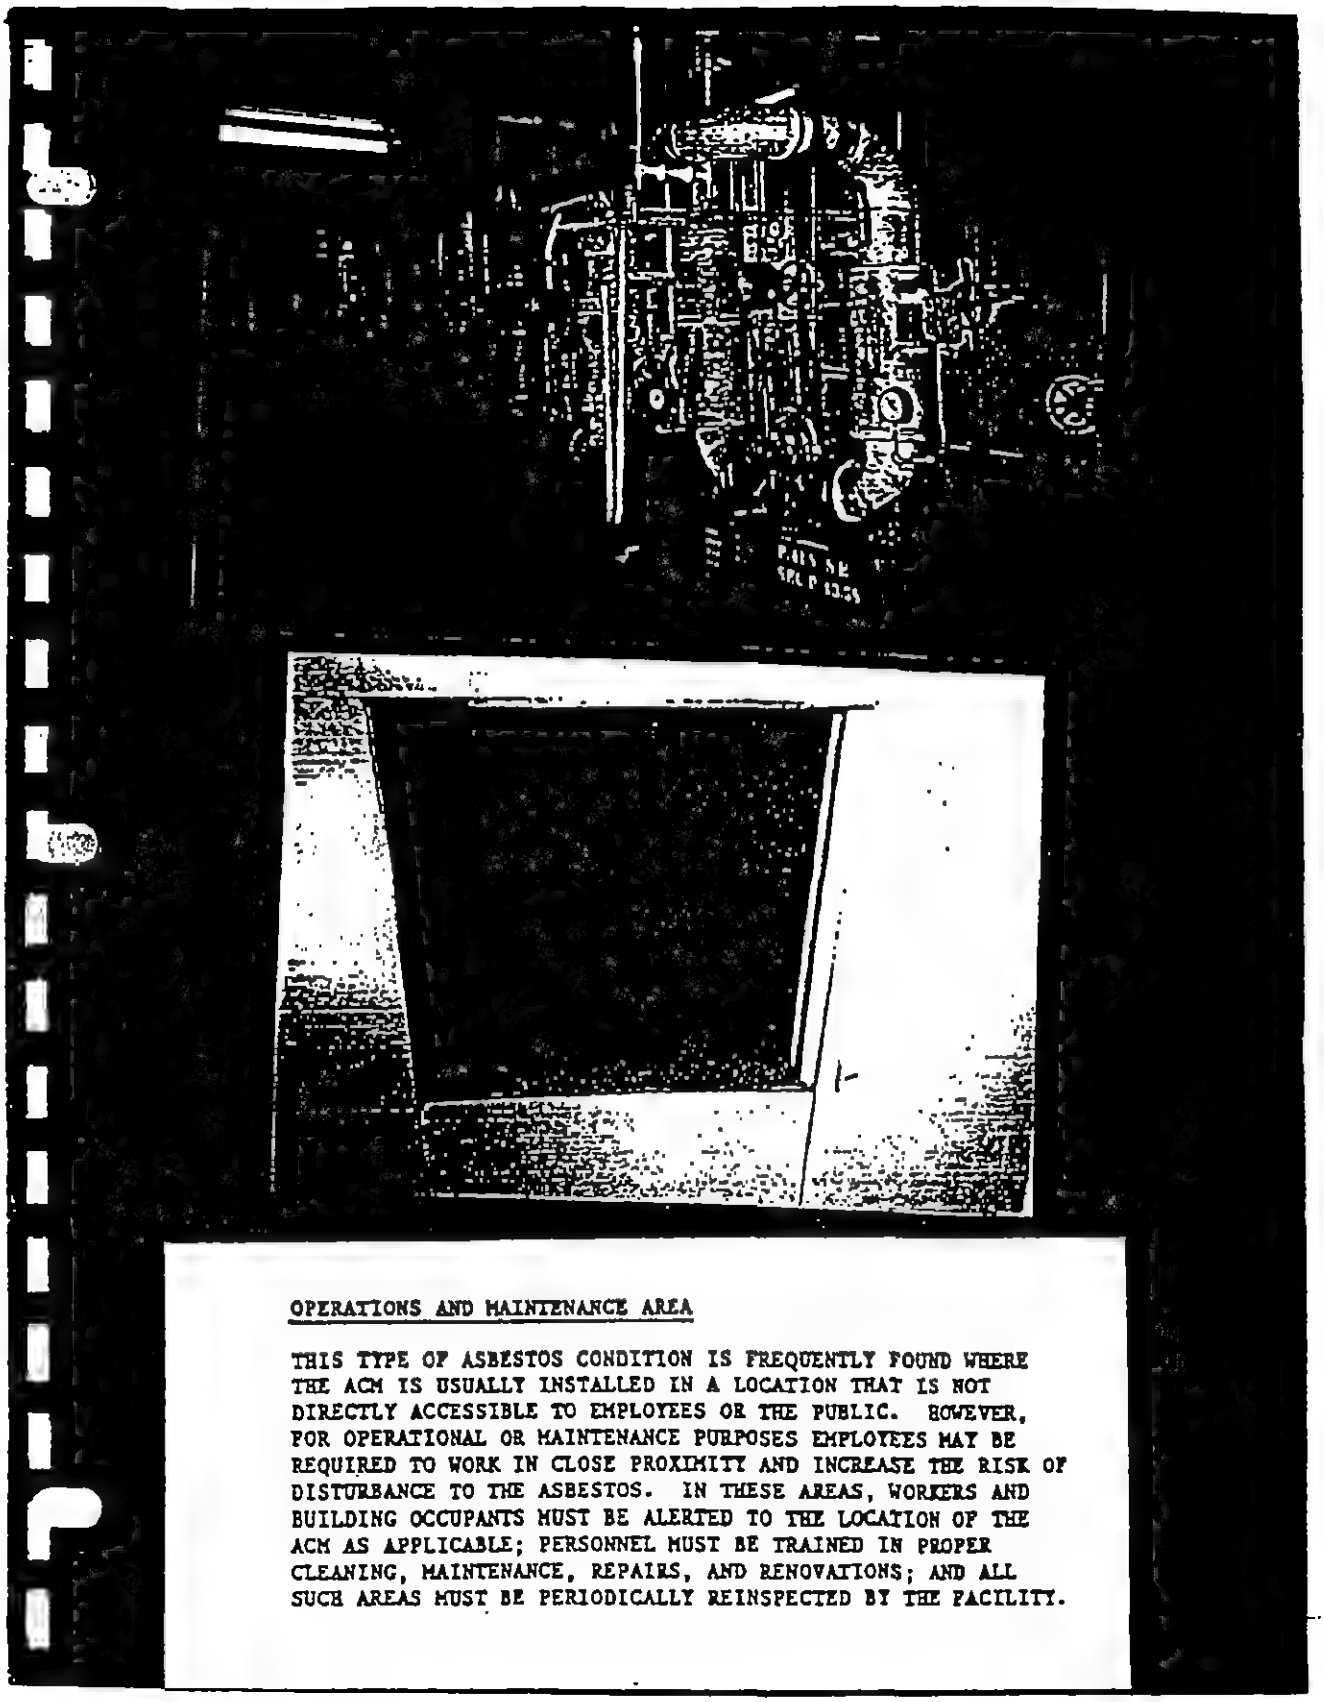
OPERATIONS AND MAINTENANCE AREA

THIS TYPE OF ASBESTOS CONDITION IS FREQUENTLY FOUND WHERE THE ACM IS USUALLY INSTALLED IN A LOCATION THAT IS NOT DIRECTLY ACCESSIBLE TO EMPLOYEES OR THE PUBLIC. HOWEVER, FOR OPERATIONAL OR MAINTENANCE PURPOSES EMPLOYEES MAY BE REQUIRED TO WORK IN CLOSE PROXIMITY AND INCREASE THE RISK OF DISTURBANCE TO THE ASBESTOS. IN THESE AREAS, WORKERS AND BUILDING OCCUPANTS MUST BE ALERTED TO THE LOCATION OF THE ACM AS APPLICABLE; PERSONNEL MUST BE TRAINED IN PROPER CLEANING, MAINTENANCE, REPAIRS, AND RENOVATIONS; AND ALL SUCH AREAS MUST BE PERIODICALLY REINSPECTED BY THE FACILITY.
